1394 OHCI

DCAM Versions

DCAM-API for Windows (April 2013) Compatibility Note

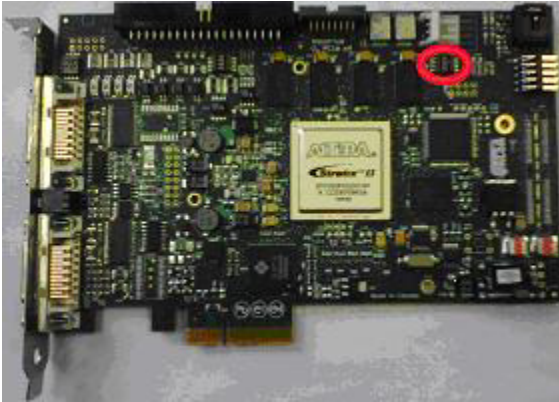
Older motherboards and/or some PCI Express 2.0 slots (Ex. - Dell T5400/T7400 x16 slots) may have BIOS incompatibilities with the Xcelera card. This usually presents itself where the PCIe slot in which the board is installed cannot initialize and a BIOS error message is shown, or the PC will not boot at all. In either case, the cause can be related to unexpected PCIe bus reset negotiations with the BIOS/motherboard and the Xcelera. A possible method to circumvent this issue is to set DIPSW3-2 to ON (right position) before installing the card into the PC. This causes the Xcelera to ignore PCIe reset requests which normally allows the card/PC to boot properly. The side effect is when the board is configured in this manner, if the board has never been initialized with the current drivers/firmware yet, a firmware flash may be attempted silently to the board after Windows startup or just after the first PnP device detection sequence. After flashing is made, the board may still be inoperable – you can know it if your DCAM-API host application fails to initialize and detect your camera after approximately 5 minutes after startup. If this should happen, a manual Windows restart should correct the issue, and the board will continue to operate properly in the installed slot. The DIPSW3 bank is located on the board at the red circled location:

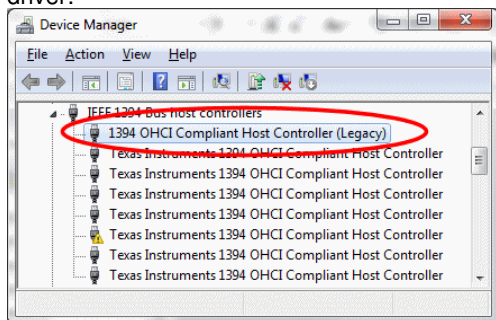
- *9: C7780 fully works with AS-PHX-D36-PCI64(-B) / -PE1 only
- *10: For Windows Vista, 16x16 binning and small regions are not supported.
- *11: For dual tap, maximum performance is not guaranteed.
- *12: C7780 has limitation for full performance with Coreco PC-DIG.
- *13: For Windows 7 only, the DFG/1394-1e Video-to-FireWire Converter requires a manual downgrade of the IEEE 1394 Bus Controller for which it is connected to the 1394 OHCI Compliant Host Controller (Legacy) driver:

See this video how to downgrade the driver: <http://www.youtube.com/watch?v=s4JfbDW6AtI>

After the driver is downgraded, you should run any DCAM-API compliant host application once as an administrator or reinstall the driver set so that the Legacy driver is properly configured for maximum speed.

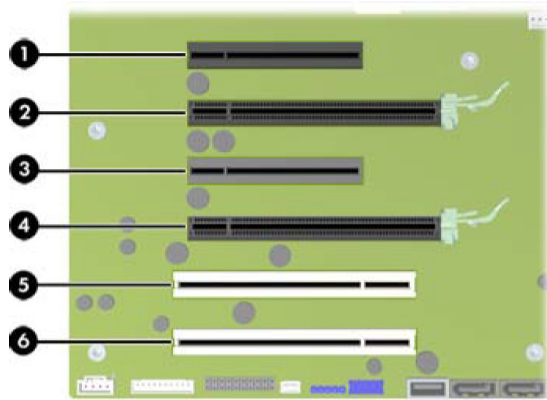
Identifying expansion card slots

The following figure identifies workstation expansion card slots.

The following table describes the workstation PCIe card slots.

Slot	Type	Slot power (Maximum)
1	PCIe2 - x8(4)	25W
2	PCIe2 - x16	75W
3	PCIe - x8(4)	25W
4	PCIe2 - x16	75W

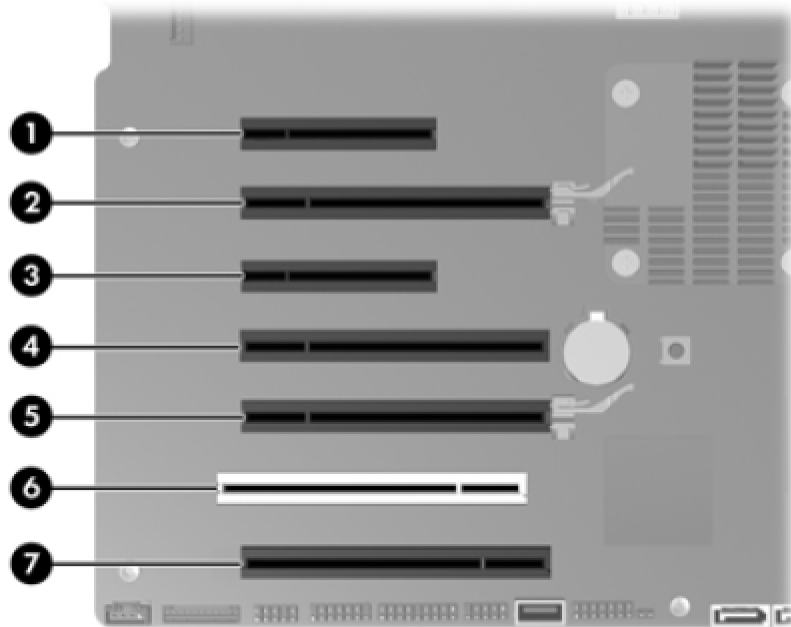
Identifying expansion card slots

The following figure identifies workstation expansion card slots.

The following table describes the workstation expansion card slots.

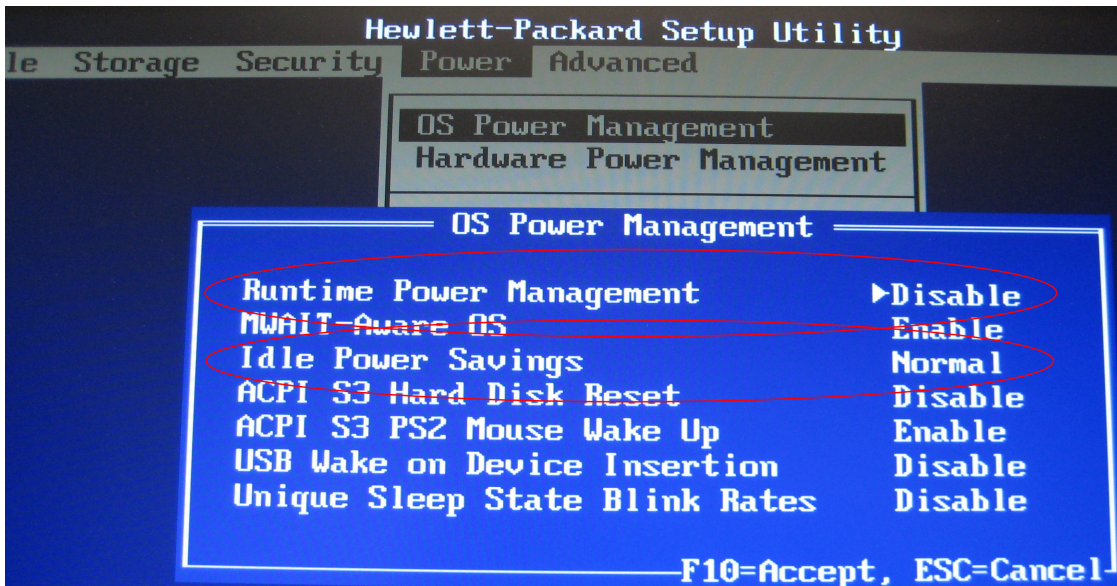
If you have an HP Z400 or Z800 Workstation, it appears in the BIOS here:

Set Runtime Power Management to Disable and Idle Power Savings to Normal. For a further description from HP (Taken from Computer Setup(F10) Utility):

Computer Setup—Power	
Option	Description
OS Power Management	<ul style="list-style-type: none">Runtime Power Management— Enable/Disable. Allows certain operating systems to reduce processor voltage and frequency when the current software load does not require the full capabilities of the processor.Idle Power Savings—Extended/Normal. Allows certain operating systems to decrease the processors power consumption when the processor is idle.

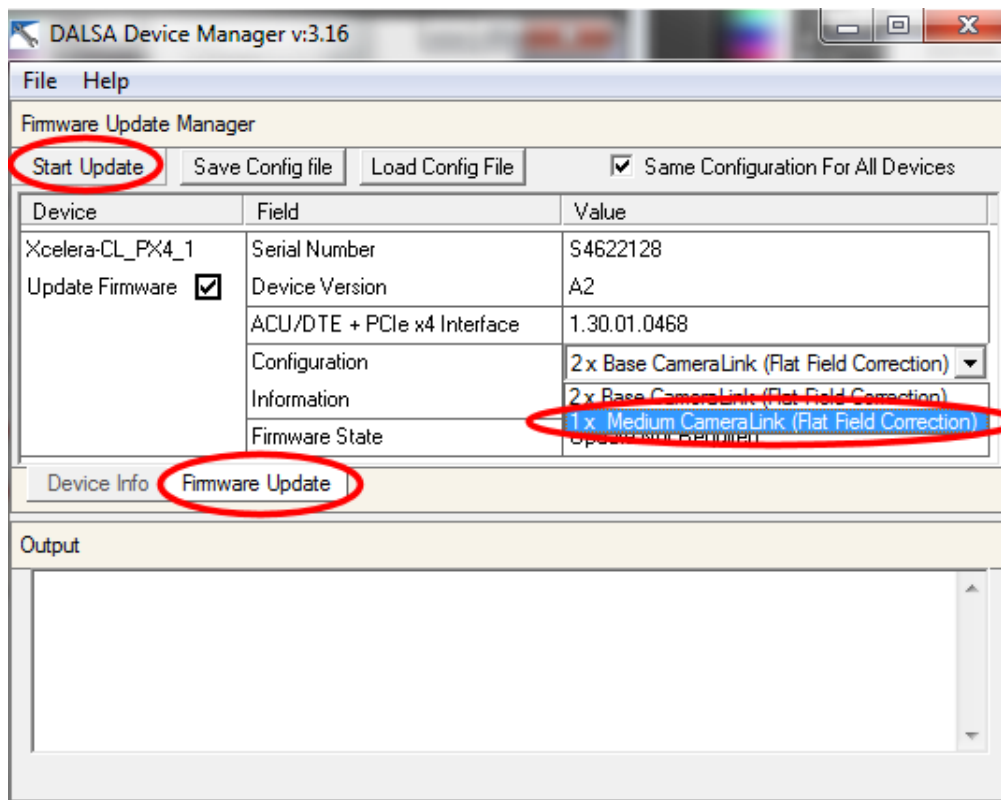
2. Press the Firmware Update tab and change the Configuration to Medium CameraLink for the board you wish to reprogram:

3. Press the Start Update button to reprogram the board. When done, do not reboot yet if it tells you.
